NAVAL RESEARCH LABORATORY  
REPORT

AIRBORNE RADIO DIVISION  
ENGINEERING ANALYSIS SECTION

TYPE TEST OF AN/APS-20A.

Report #R-2957

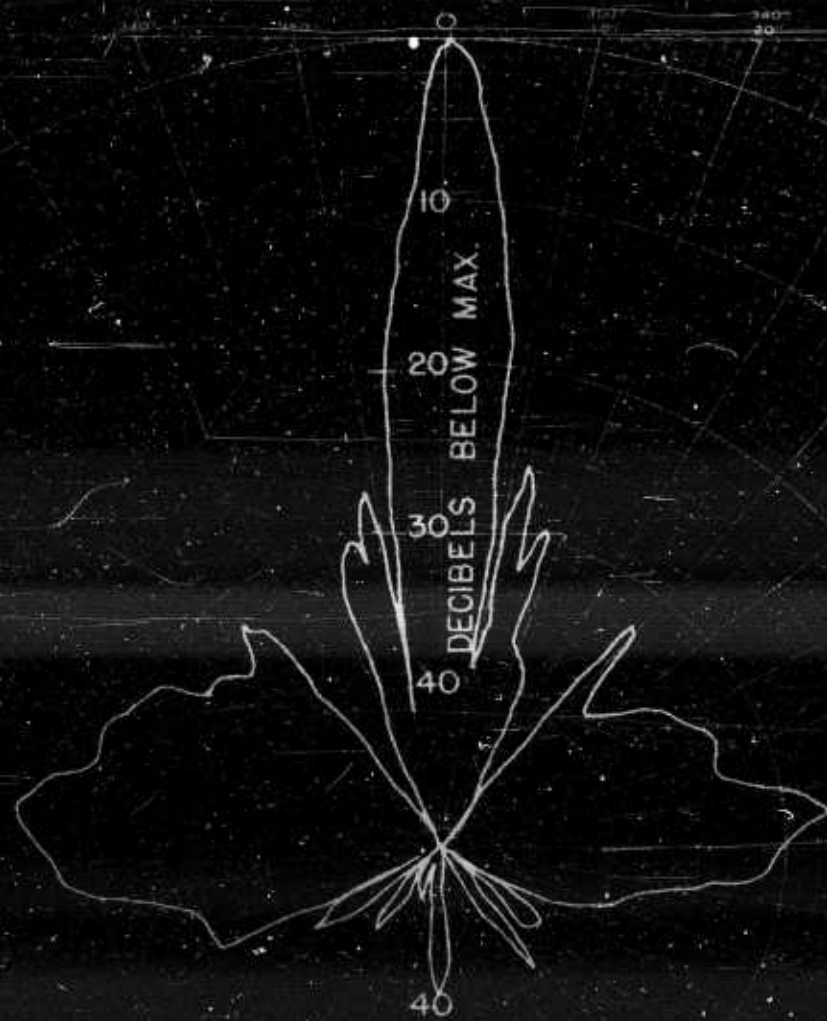
HORIZONTAL PATTERN WITH  
NAGELLE IN PLACE

1. The antenna beam width in the horizontal plane was found to be 3.5°. The side lobes of the pattern were less than 1% (Reference Plate 1).
2. The voltage standing wave ratio was found to be less than 1.2/1.
3. The noise figure of the I.F. amplifier was found to be 2.5 db.
4. The receiver was found to be 10 db below an ideal receiver.
5. The A.F.C. will maintain the local oscillator frequency under transmitter variations of  $\pm 15$  megacycles.
6. The sweeps from the local, delayed, and remote scopes were satisfactory, except when the 3GEA2B2 regulator on the 3-phase generator was not adjusted properly. Maladjustment of the regulator causes a large low frequency ripple on the input voltage.
7. The variations of voltage with change in input A.C. frequency can be found in Table 1.
